Brougham Place Uniting Church

Property Status REPORT

for Brougham Place
Parish Council

January 2005

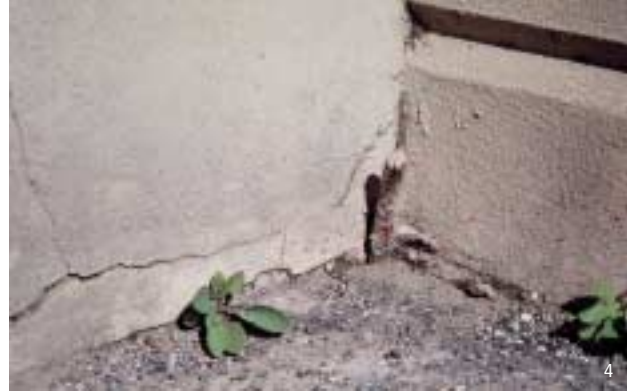
- The area to the left of the building where the sign board is located has a deteriorated and porous sealed surface. (See Photo 4). This surface should be re-instated to prevent water seepage into the foundation, wall & tank room area. The base of the lightening conductor is evident in this same area (see section 1.5 "Lightning Conductor").

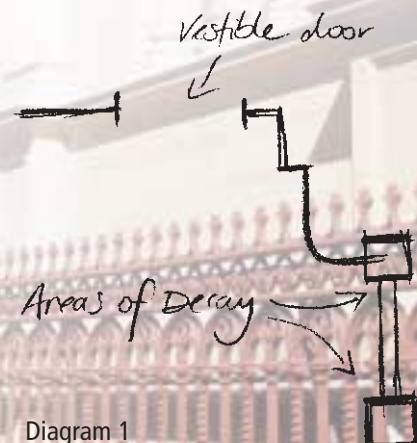
- The fence needs some minor repair work where it adjoins the church building near the North Vestible Door. Minor render repairs are also advisable to the two main pillars (see illustration right).

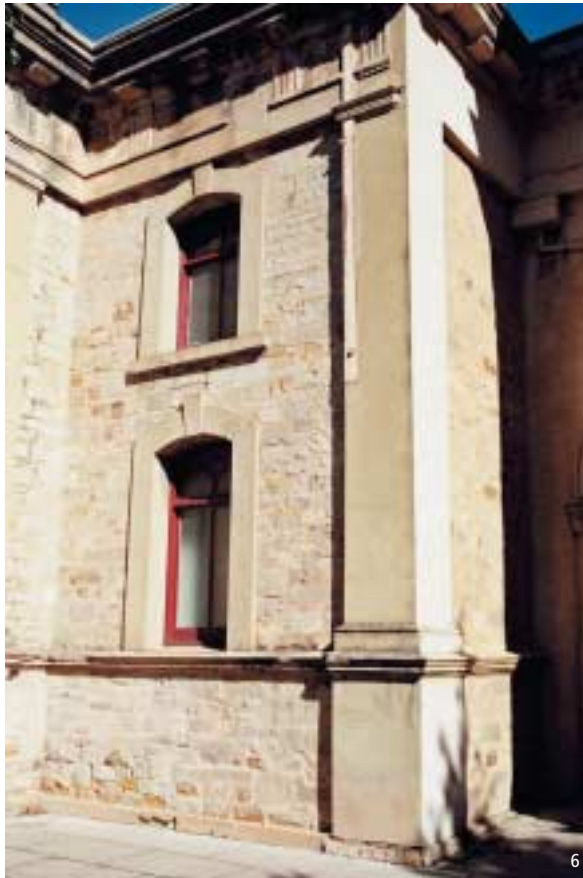
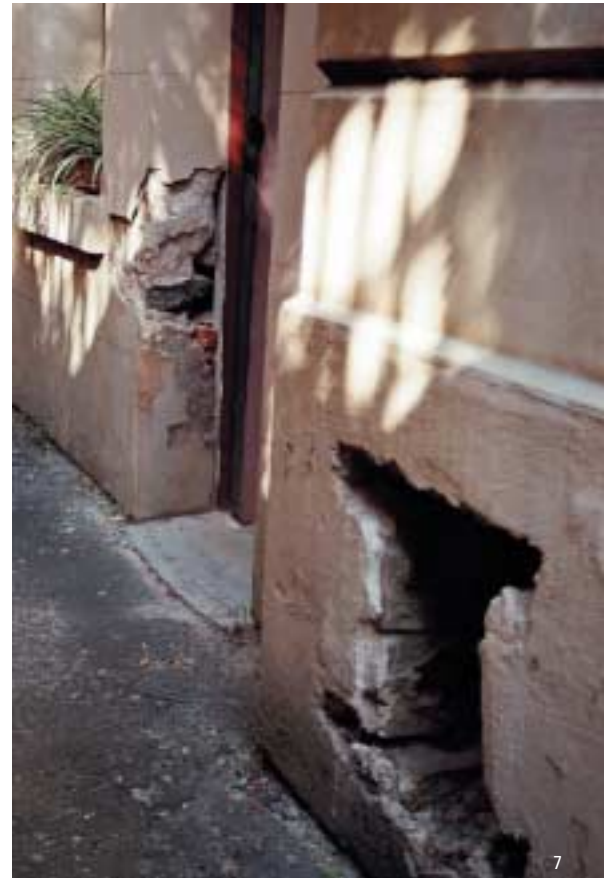
- Rainheads & downpipes located over the vestibule doorway need replacing & painting.
- Tidy up needed to cable on the LHS of the vestibule door. (Encase in a conduit fixed to the wall).
- Vestry link stonework in sound order but needs to be repaired. Cracks to be filled, re-instate pointing and repair & render corbelling where necessary. (See Photo 6 below).

- The area to potentially cause most major ongoing problems is that of the lower north facing church wall adjacent to the exit door from the Parkin Room. This wall section requires:

- The walkway has a bituminous type finish in very poor condition and its porous condition, together with a general lack of light is adding to the speed of degradation to the wall. There appears to have been a build up of this pathway/paved area over time, possibly due to repeated over spraying/sealing over the years. This area needs to be dug up and the existing material removed and then replaced with a base layer & new sealer, either hot-mix bitumen or concrete (preferably), with caulked seal between the base of the wall render and the resurfaced path. (See Photo 7 above).

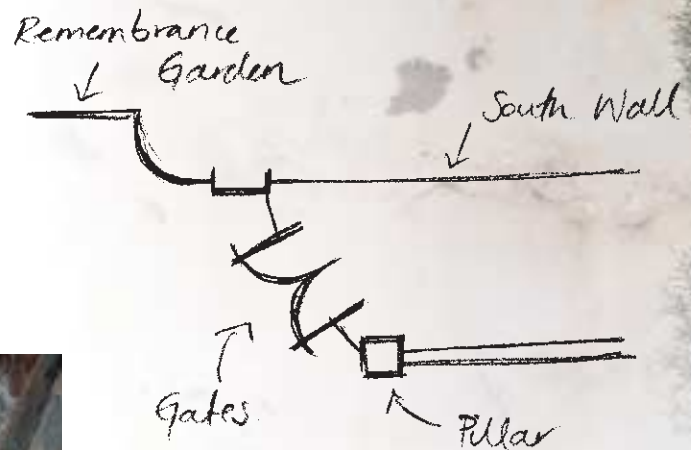
Diagram 2

- Garden of Remembrance wall (retaining wall for front steps). Remove slurry render, clean up & repair wall and re-render.
- Repair render to gate column as illustrated.
- Some minor repair work should be undertaken to the render coat on the main wall face, near the office & hall entry points.
- Repaint all iron work.
(See Diagram 2).

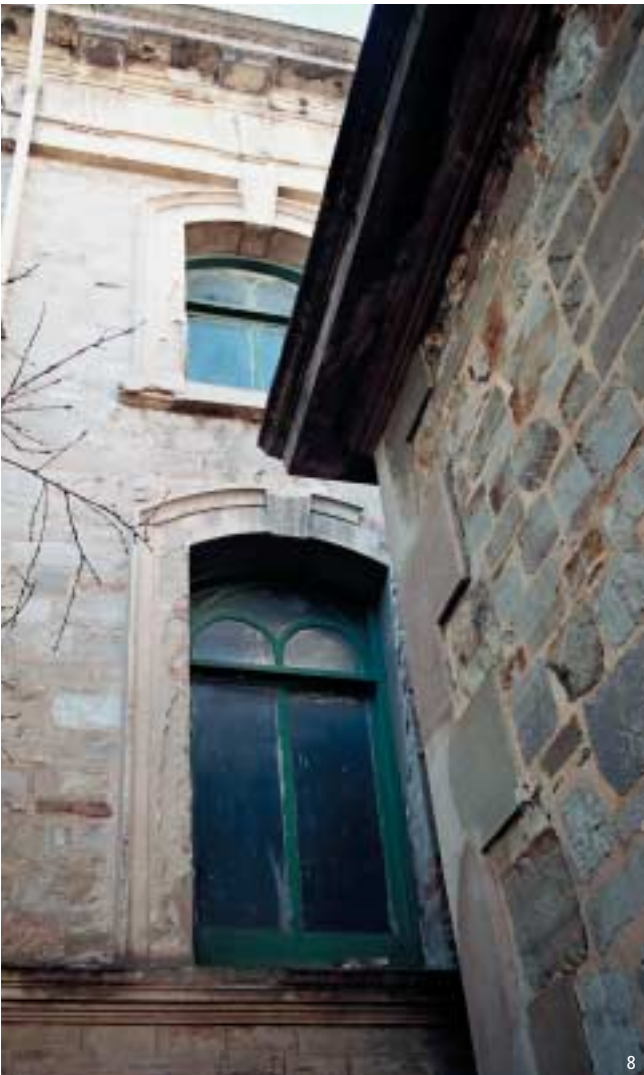
Vestry Link

- The south side of the wall is in poor condition, structurally sound but suffering from long term neglect.
 - Clean & repoint where necessary all stonework.
 - Replace or re-instate mouldings, corbels etc to retain authenticity. It may be acceptable to "plain point" or to render this wall to match the main church building, or alternatively to use custom mouldings, rather than go to the expense of plaster mouldings.
 - Clean out all roof downpipes ensuring that there are no blockages remaining.
 - Repair render near the step by the external Flower Room door.
 - Install new grill to left hand side of door step, clean and make good stormwater system.
 - Reinststate paving underneath & adjacent to the Potted Ficus tree.

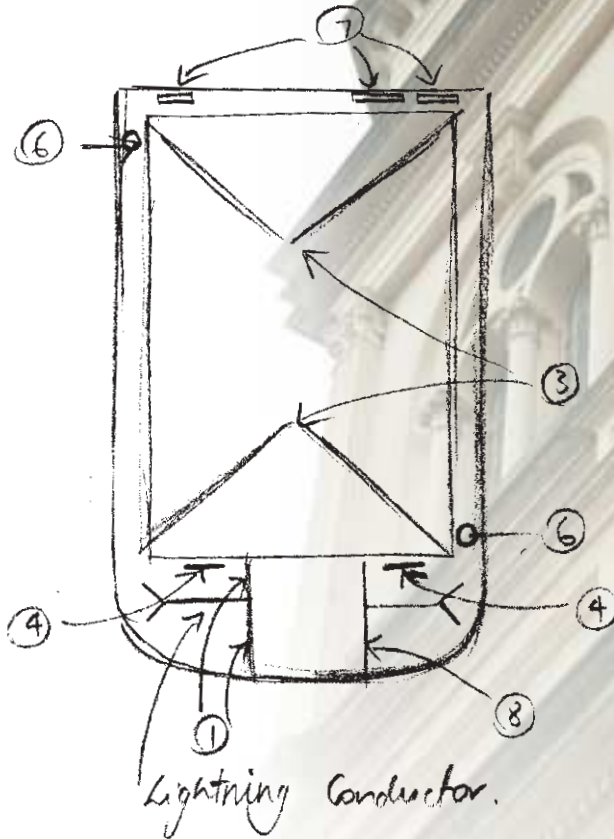
1.4 The Roof

1. Lead flashing on the northern side of the belltower is perforated (at junction with iron roof) and needs resealing on some edges.
2. The corrugated iron roof itself appears in good condition, however across its entirety there are many loose nails. Whilst some of these will respond to hammering down, most should be removed and replaced with roofing screws.

3. Roof vents - All roof vents are in extremely poor condition with perished woodwork, badly corroded birdwire and will need to be fully replaced. Suggest custom made galvanised iron vents with internally fixed bird/fly/bee mesh. Base flashing should be replaced as part of this process.

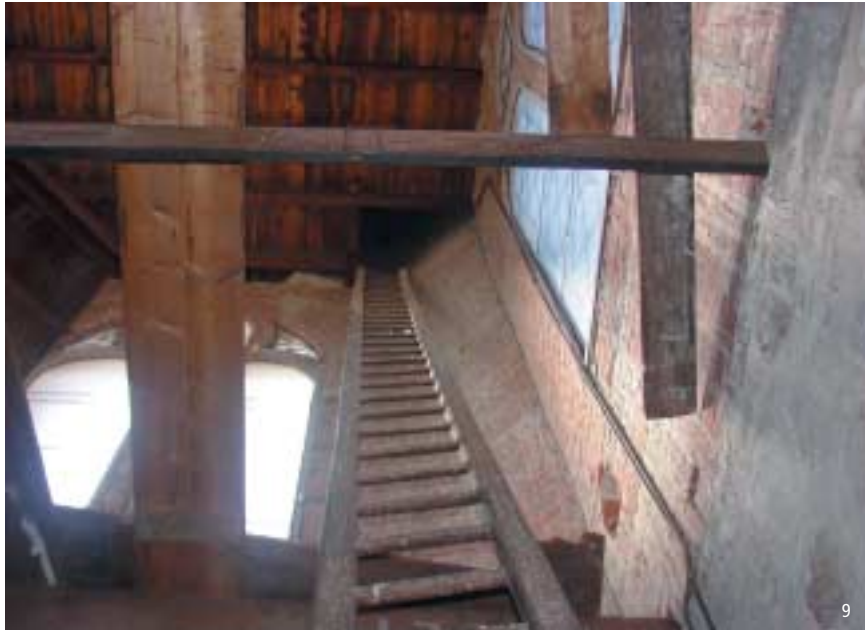
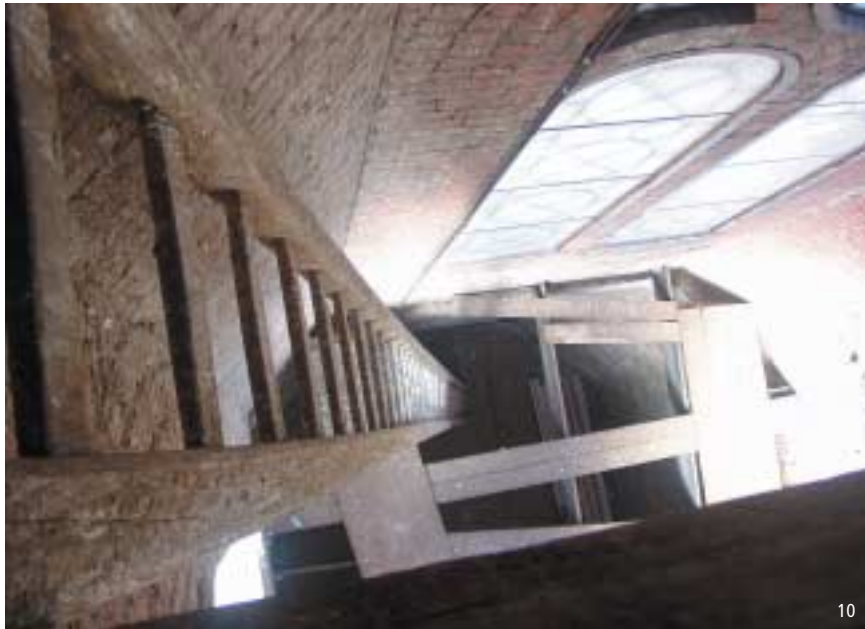
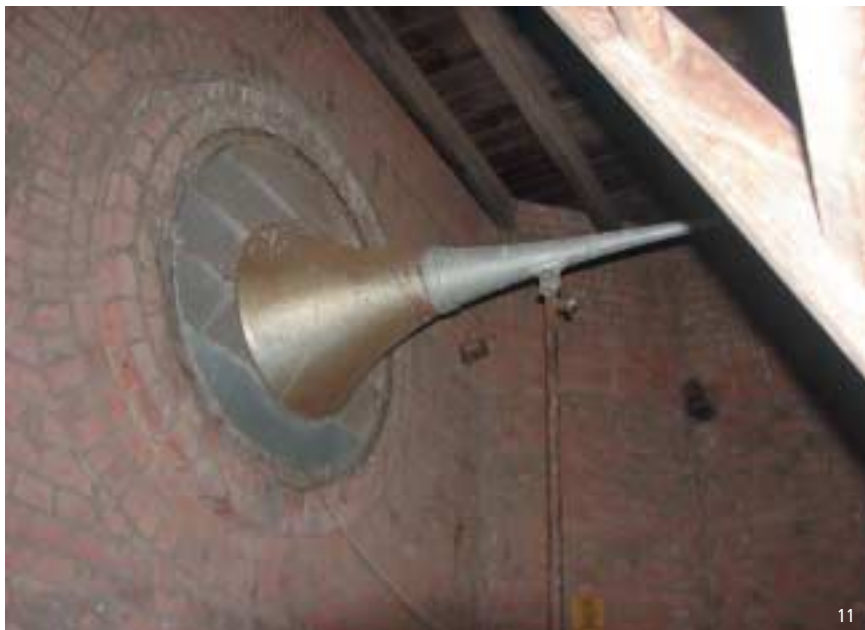
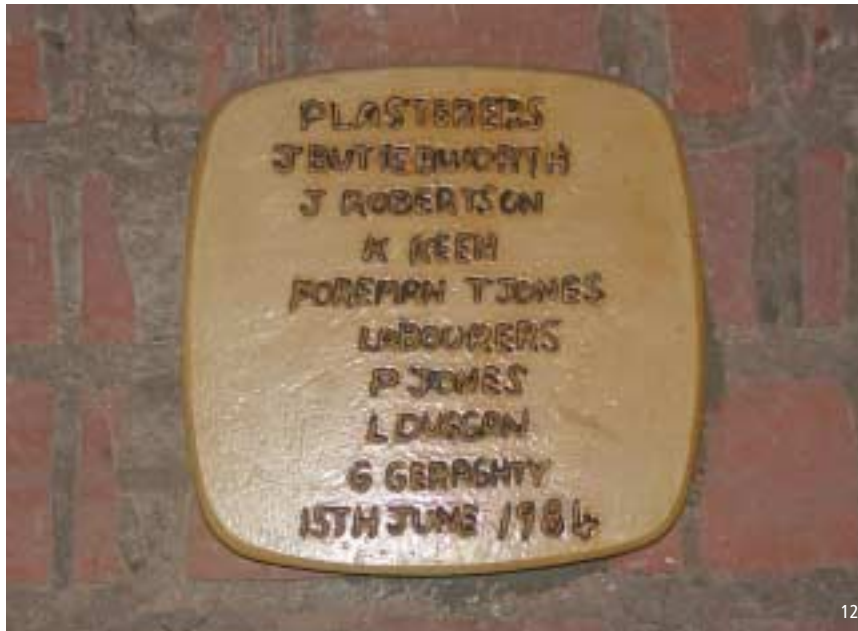
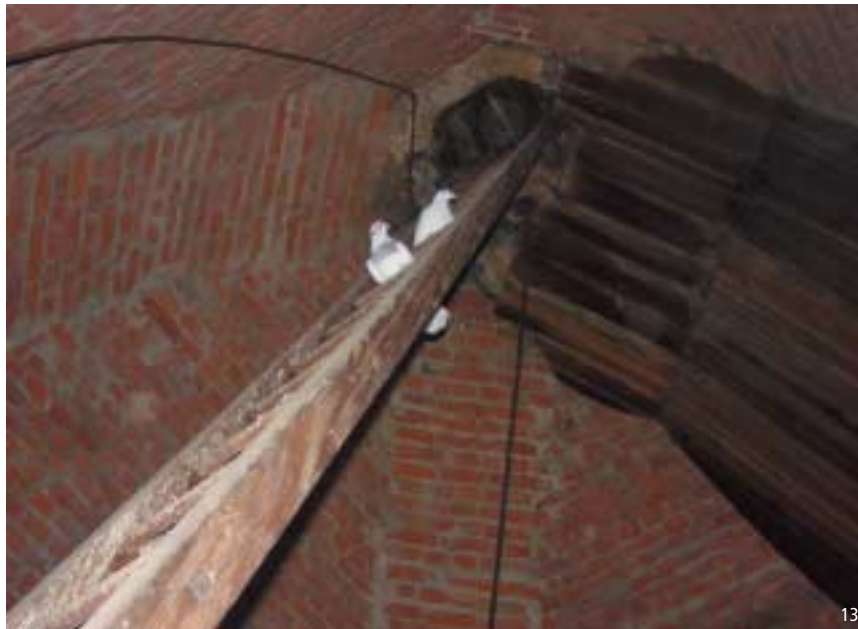
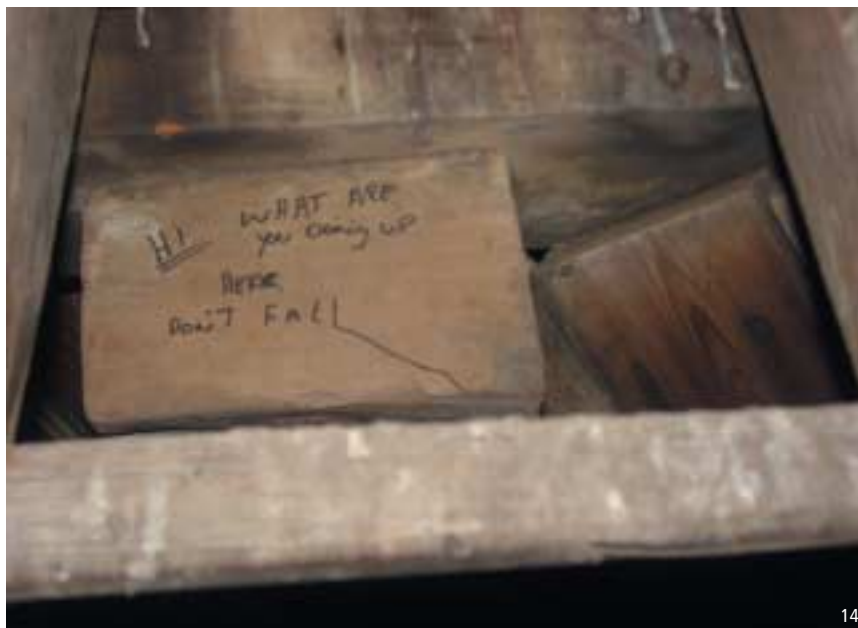
- Proper reinstatement of the platform floor over the second level is recommended and the provision of some lighting to this level is also recommended. The current arrangement of random planking is totally unsafe and must not be used at all.

- Conduits running across the second level floor are dangerous.
- All electrical cabling in the belltower needs either removing or upgrading.
- The strong evidence of pigeons will not be fully overcome until the roof vent system is renewed.

- The series of photos show the Bell tower in detail from the entry level above the foyer ceiling right to the top! (see over page).

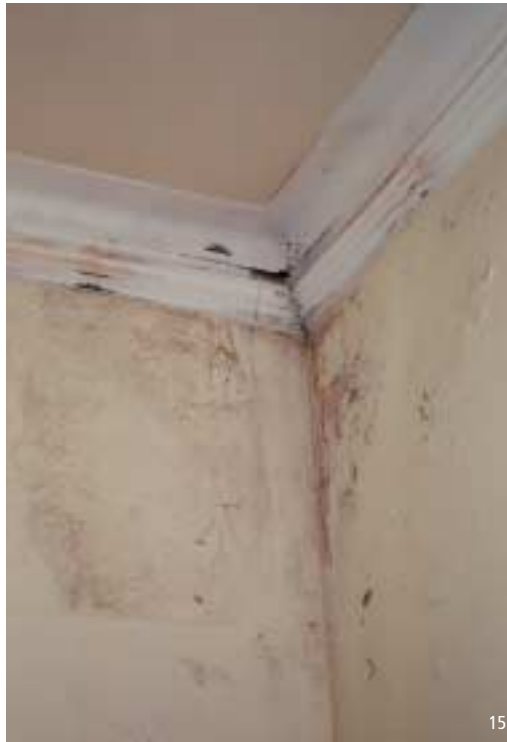
1. Stairwell to Mezzanine: Ensure that water damage at the ceiling level is historic and no longer occurs. Investigations made during wet periods through the course of this project suggest that there is no current activity and rainheads appear clean and clear. Recommend that plaster work be made good prior to repainting this area. (See Photo 15 below).

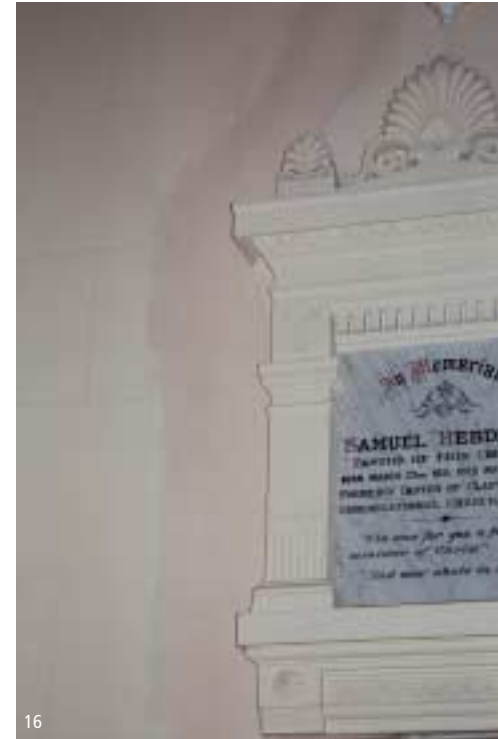
- There is no concern in regard to the main seating area, although there is poorly matched repair painting associated with the speaker system where wiring has been channelled into the walls. (See Photo 16 right).

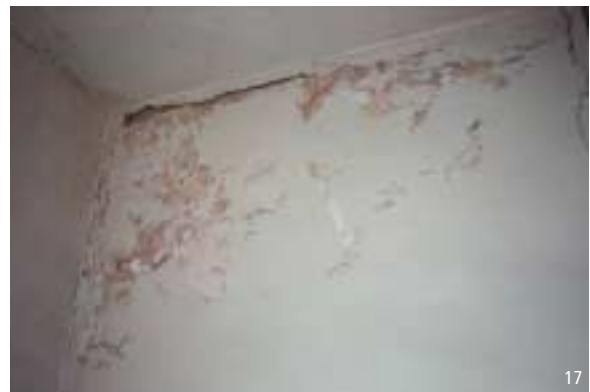
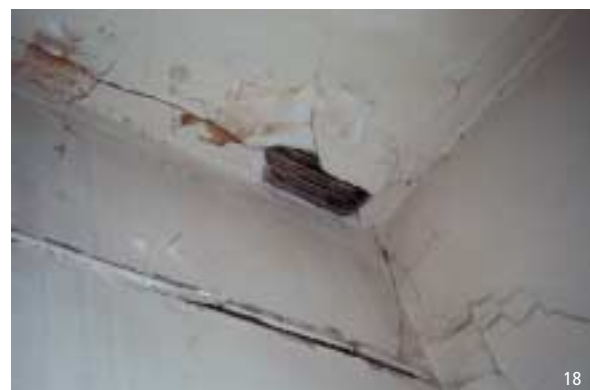
- The stairs to all levels are sound and are aesthetically & historically quite outstanding.
- Stairwell to lower ground and ground level requires repairing and repainting although repairs are minor.
- The upper stairwell is cantilevered from the wall and this has 'come away' from the wall slightly. It is recommended that the newel be extended from the undercroft level in the same manor as has been done on the northern lower end. By doing this (at minimal cost), the upper level will be correctly supported and will not 'creep' further from the wall.
- Upper stairwell requires repairs and repainting (See Photos 17 & 18 right).
- Upper staircase requires re-polishing

- Reinstall ceiling; placing in it a 'new' period style stained glass skylight
- Repair walls & repaint. (See photos 17 & 18 on page 22).

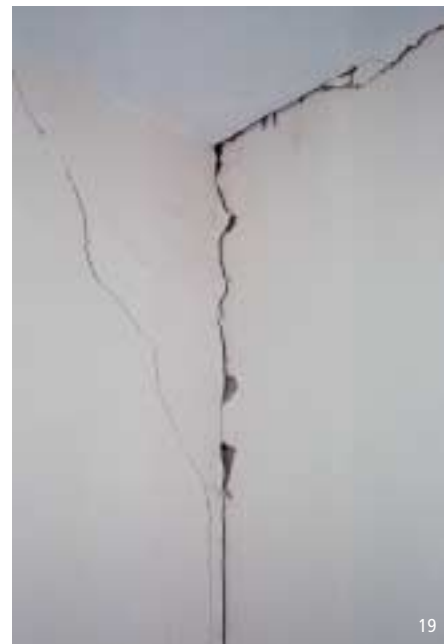
- Repair cracks using a flexible base filler as per vestry immediately below and repair the ceiling. (See Photo 19 right).
- Repaint
- Repair floor at doorway to alleviate gap & recover floor.

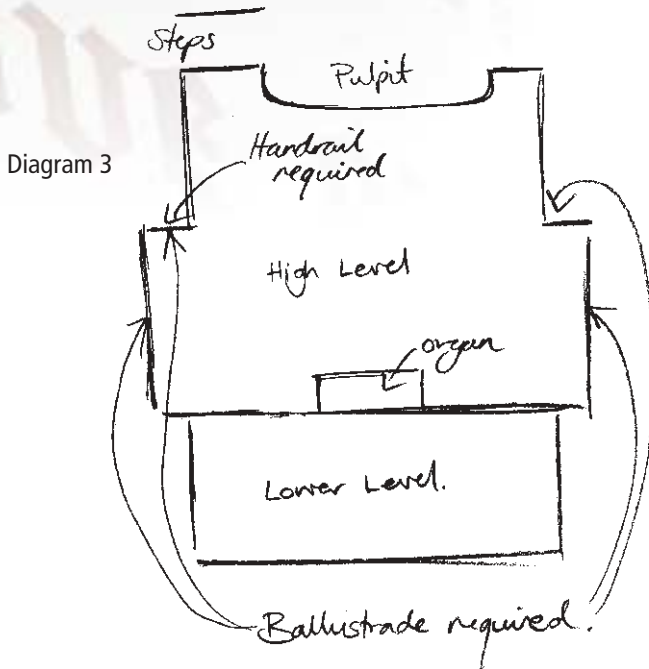
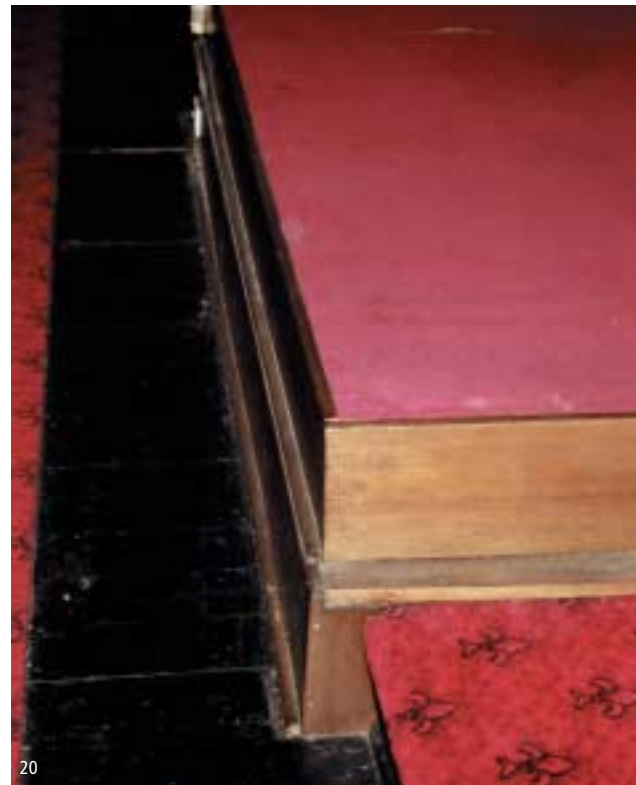
RISK = Medium

The long ramp is seen as adequate as is the turning and access area to the door, although none of it strictly meets the disabled code. There is a problem both of compliance and practical efficiency, however with the doorway itself the restriction in space makes it very hard to open the screen door and the main door and there is a small step. This is the only disabled access to the toilets.

REQUIRED ACTION = Balustrade.
