Brougham Place Uniting Church

Property Status REPORT

for Brougham Place
Parish Council

January 2005

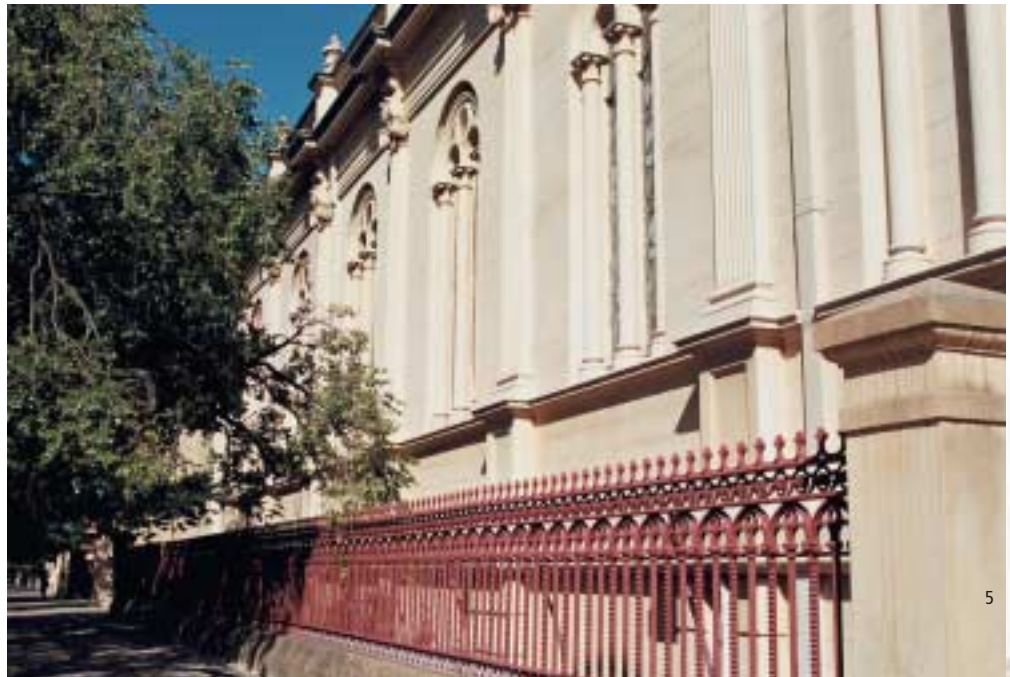
- The fence needs some minor repair work where it adjoins the church building near the North Vestible Door. Minor render repairs are also advisable to the two main pillars (see illustration right).
